**EDF-ER-213, Revision 1, Result of FY 2000 Soil Sampling at  
the SPERT-II Leach Pond, CERCLA Site PBF-16, OU 5-12**

# Engineering Design File

PROJECT NO. 23366

## Results of FY 2000 Soil Sampling at the SPERT-II Leach Pond, CERCLA Site PBF-16, OU 5-12

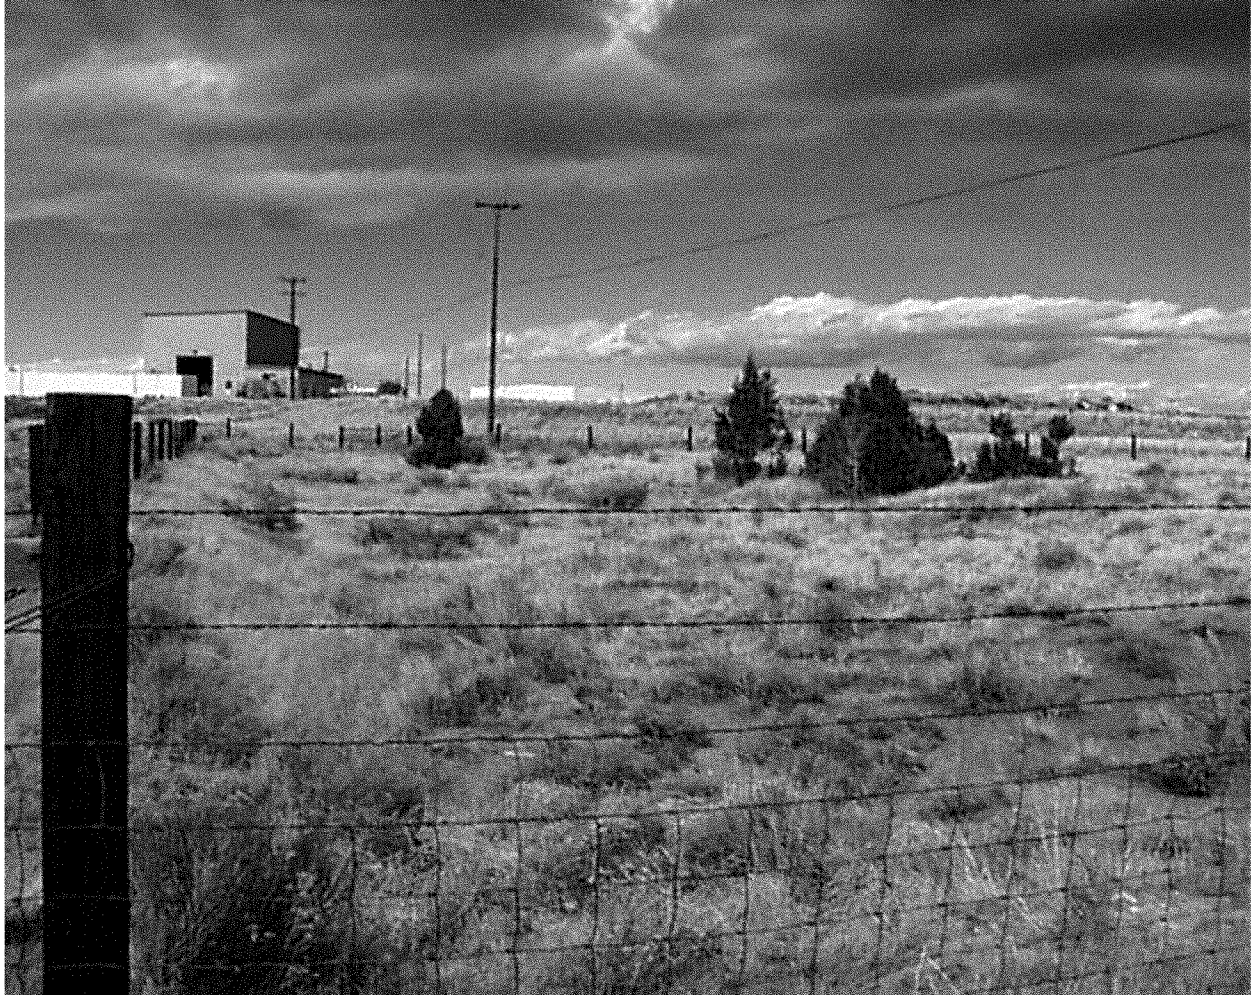
Figure 1-1. PBF-16 (SPERT-II) leach pond and fence with SPERT-II reactor building in background.

The Special Power Excursion Reactor Test No. 2 (SPERT-II) reactor was a low-pressure, heavy water nuclear reactor that operated for five years from 1959 to 1964. The Power Burst Facility (PBF) SPERT-II Leach Pond (PBF-16) is located approximately 300 ft. south of the SPERT-II reactor building (PBF-612). It has maximum dimensions of 167 × 230 ft., and is surrounded by a six-sided, mesh and barbed wire fence, with a 10 ft. gate located on the east side. Figure 1-1, is a view of the pond area looking north towards the SPERT-II reactor building. Directly beneath the fence, along the west and south sides, is a compacted gravel base course. A berm extends along the northwest side of the pond area, outside of the fence. A 4-in. vitrified clay drainpipe originating at the reactor building and terminating at the leach pond was used to convey waste effluent to the leach pond. The outlet for the clay drainpipe rests on a concrete and rock apron in the northwest corner of the pond basin.

Initially, the history and physical layout of the site was considered to evaluate potential spatial heterogeneities. Based on observations, topographical maps and information from the *SPERT-II Leach Pond Characterization* (Crews 1982), the PBF-16 pond area was divided into two strata; specifically, 1) Stratum 1—the area of the pond that actually received effluent discharge from the SPERT-II reactor operations, and 2) Stratum 2—the are of the pond that did not receive discharge. These two strata are shown in a plan view of the PBF-16 pond in Figure 3-1. The depressional area that dominates Stratum 1 is also visible in Figure 1-1.

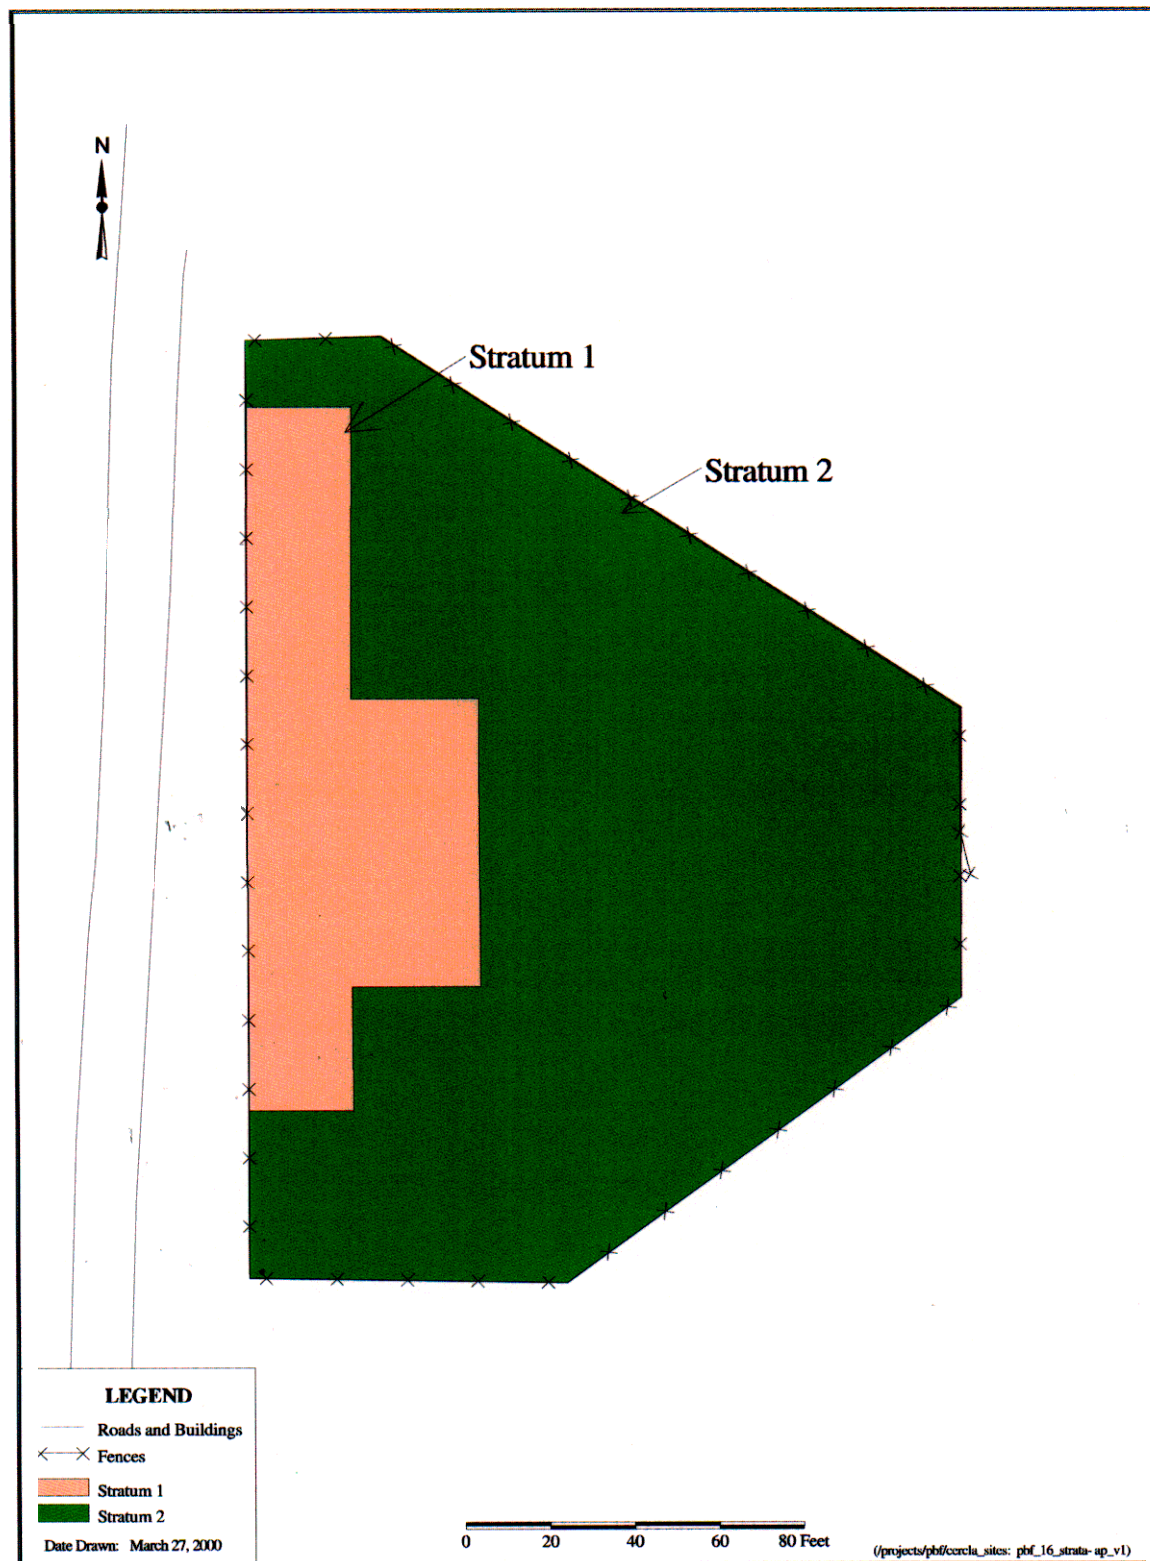
Figure 3-1. Plan view of the PBF-16 leach pond and the two identified strata.

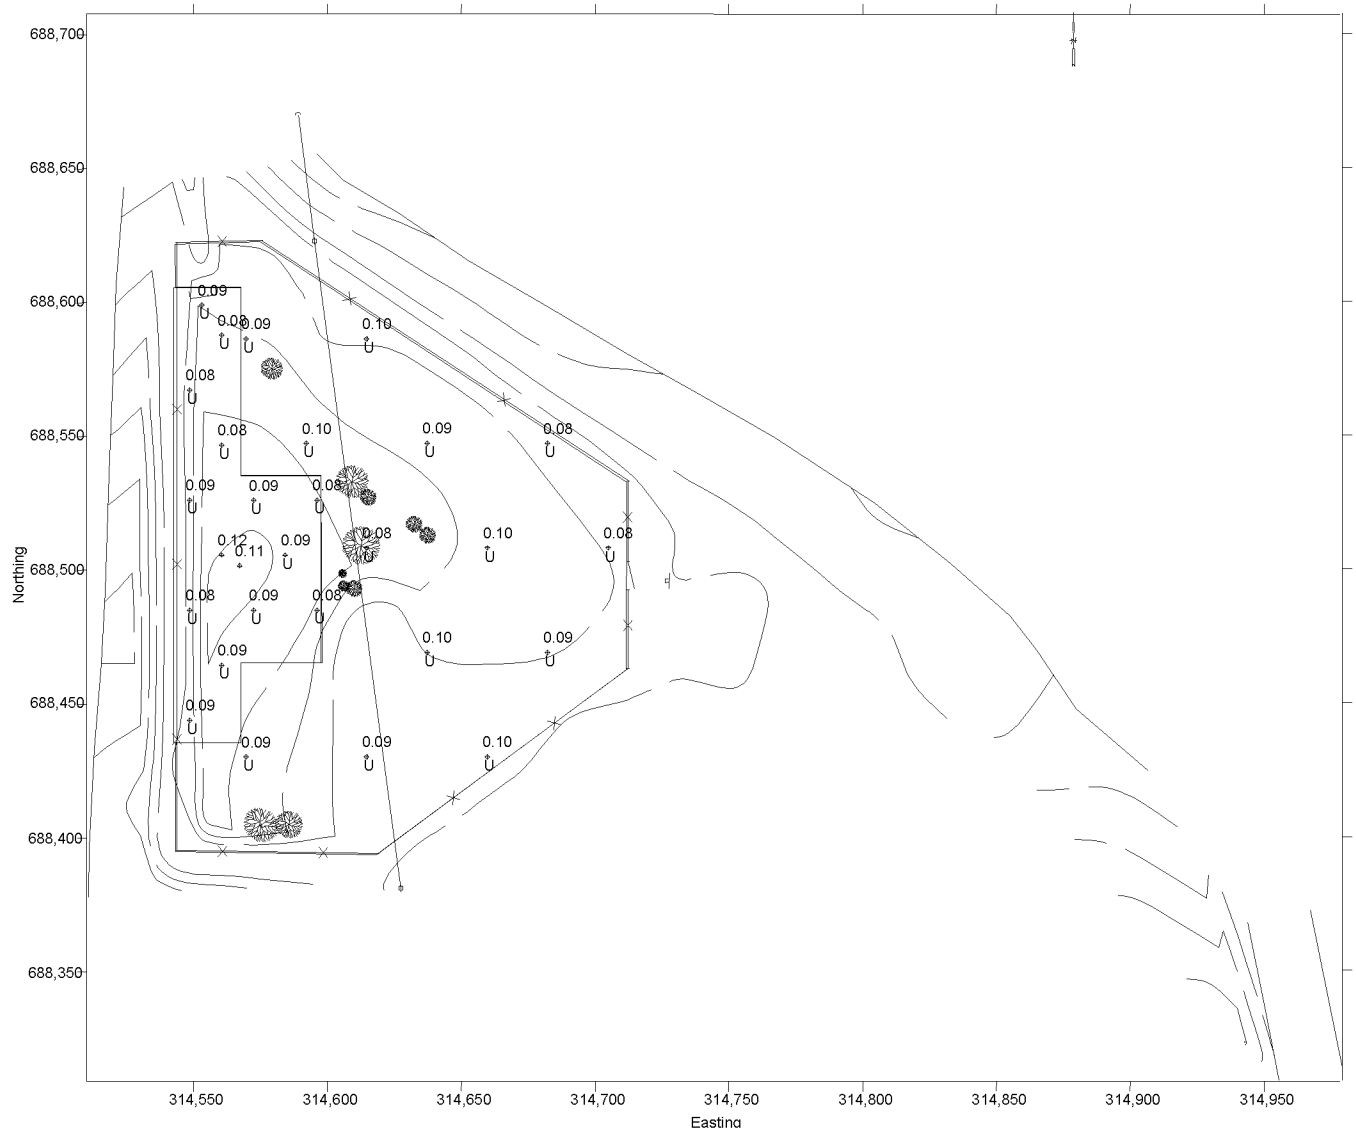
Figure 4-2. Surface (0 to 0.5 ft.) mercury sample results.

Initial laboratory analyses for this field sampling effort included total mercury for all samples. The analytical results for the mercury analyses are listed in Attachment 1. The results of the surface (0 to 0.5 ft.) and subsurface (0.5 to 1.5 ft.) sampling and analysis for mercury are shown in Figures 4-2 and 4-3, respectively.

As can be seen from Attachment 1 and Figures 4-2 and 4-3, three samples contained mercury at levels above the instrument detection limits. The maximum concentration was 0.23 mg/kg at sample location B1 from a depth of 0.5 to 1.5 ft. The minimum concentration was 0.11 mg/kg at sample location B2 from 0 to 0.5 ft. Mercury was also detected at location S1-7 from 0 to 0.5 ft. at a concentration of 0.12 mg/kg. None of the sample results exceeded the 0.5 mg/kg remedial action goal for mercury.

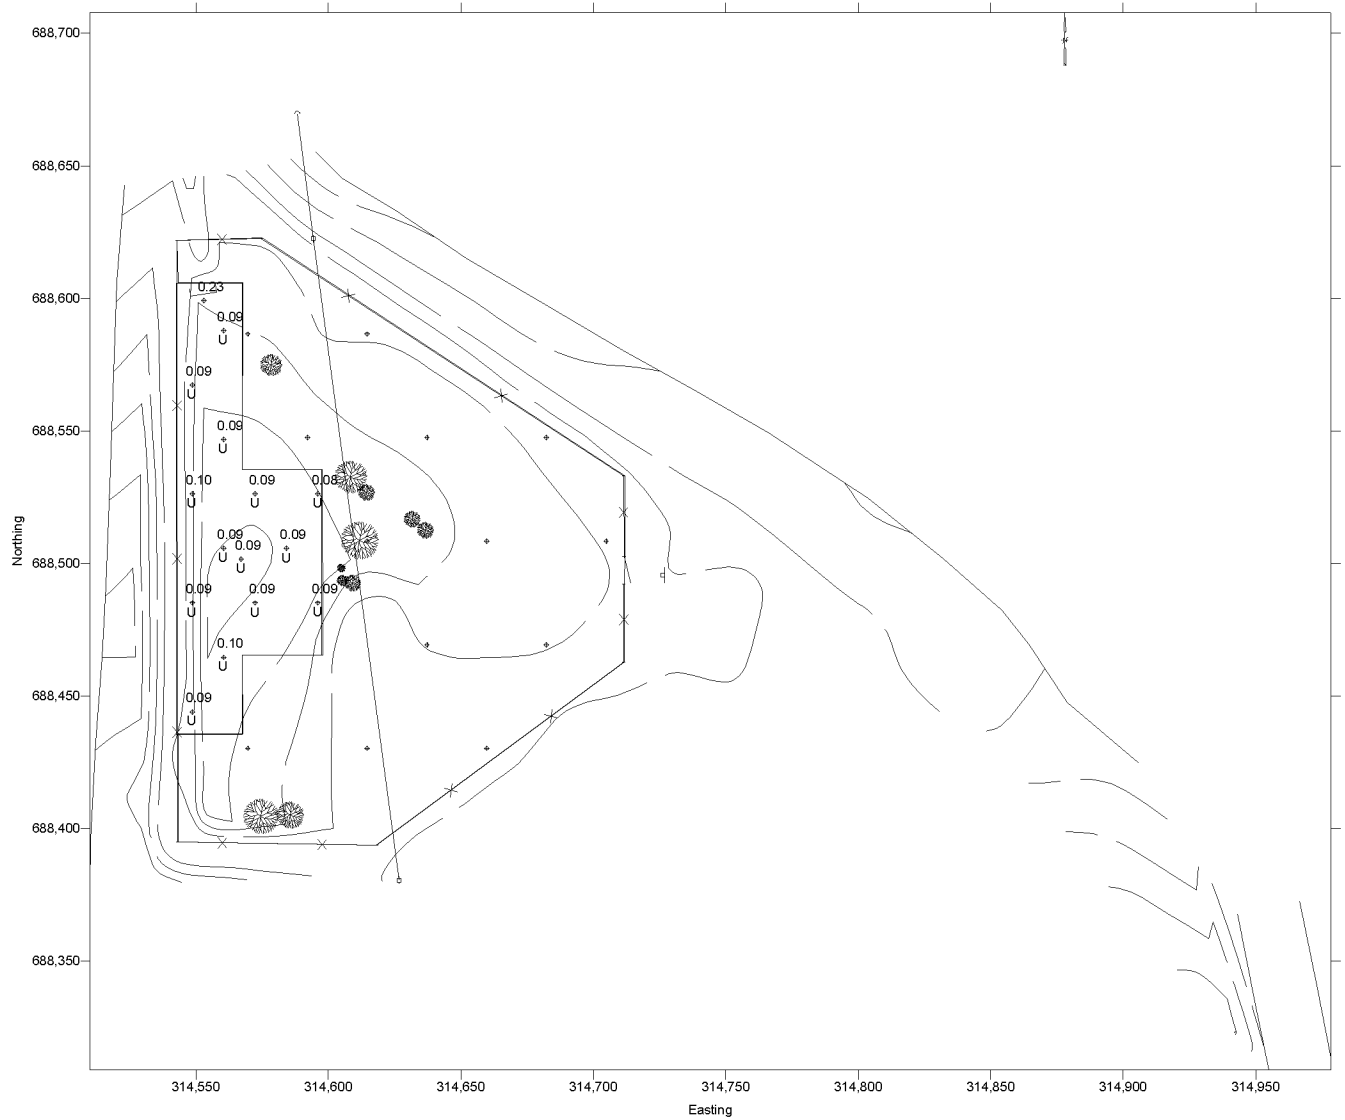
Figure 4-3. Subsurface (0.5 to 1.5 ft.) mercury sample results.
